Live Detection of Cable Insulation Aging Defects in 35kV Switchgear

Abstract: Through the live detection of partial discharge, it is found that there is an insulation discharge phenomenon at the end of the B phase cable of a 35kV Switchgear. After power failure inspection, it was found that there was obvious discharge traces in the contact position between B phase cable and ground whip. After the disintegration of the cable head, it is found that the production process of the cable head is bad and the shielding layer is missing, which leads to the uneven local electric field. Meantime, it is also found that there is an aging phenomenon in the main insulation of B phase cable, and its colour has been changed from white to dark yellow. The insulation defect is effectively discovered by the live inspection work, which makes the occurrence of power accidents be avoided with the equipment long-term operation.

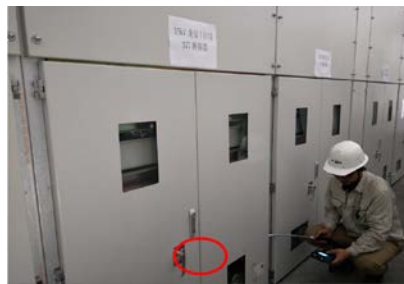
Fig. 6 PD location of 35kV 377 Switchgear

According to the characteristics of fast ultrasonic attenuation and strong directivity, ultrasonic amplitude positioning method was used to analyze the ultrasonic signal. Through ultrasonic positioning detection, it is judged that the discharge source is located near the B-phase position of the lower part of 377 Switchgear of 35kV Longxin I line. The on-site detection diagram is shown in Fig. 6.

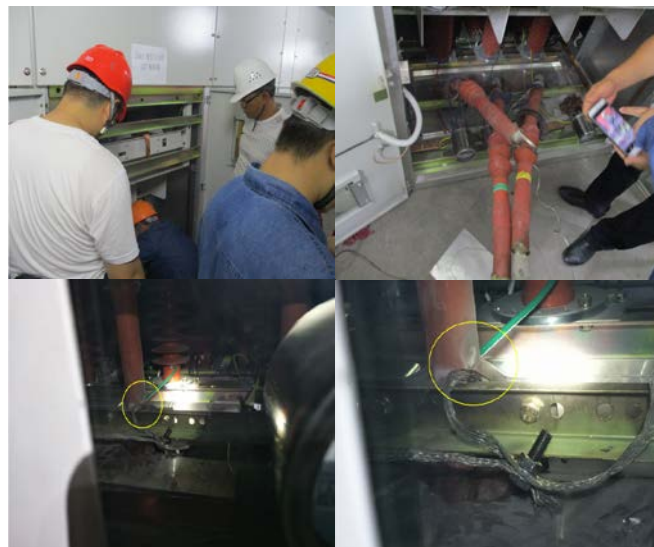
Fig. 7 B phase cable surface discharge traces of 35kV 377 Switchgear

On July 25, 2017, the electrified inspection technicians conducted a power outage check on the “35kV Longxin I line 377 Switchgear”. It is found that there were obvious discharge marks at the contact position between B phase cable and grounding whip at the lower part of 377 Switchgear. The grounding whip produced corona discharge on B phase cable. There were obvious discharge marks on the outer surface of the cable. The discharge marks were shown in Fig. 7.

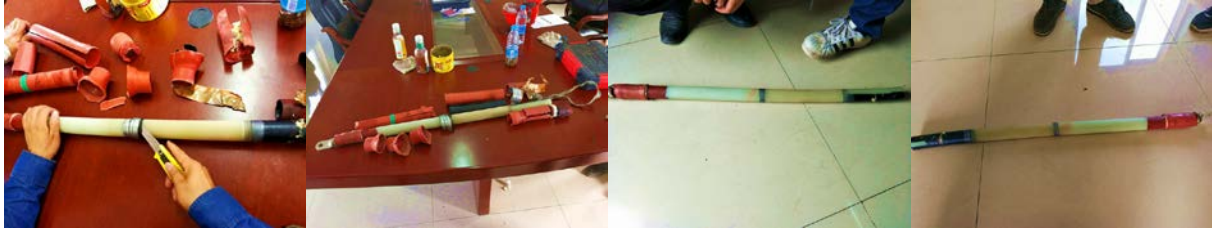
Fig. 8 B phase cable anatomy of 35kV 377 Switchgear

Anatomical analysis of this B phase cable shows that the main insulation of the cable is aging, and the main insulation layer changes from white to dark yellow. In the course of dissection, it was also found that the fabrication technology of cable was not good, and the shielding layer was absent, which resulted in the local electric field non-uniformity. The B phase cable is dissected as shown in Fig. 8 .
